Floor Screed Failure

TRADE CLASSIFICATION FOR REFERENCE

M10 Cement based levelling / wearing screeds

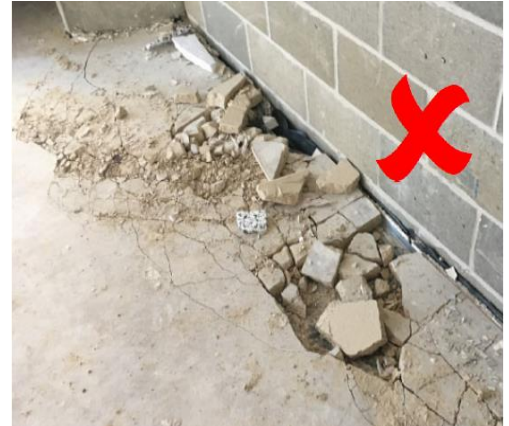
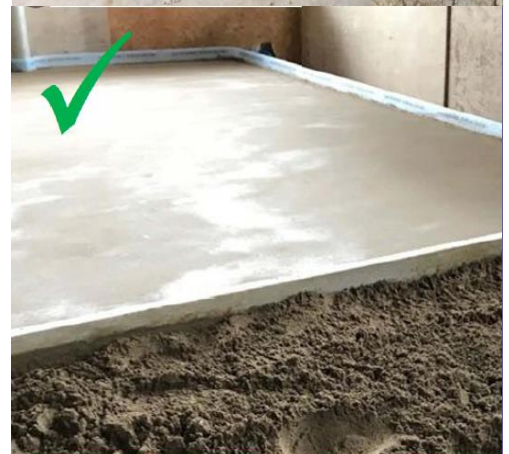
Cracking and/or total failure of floor screeds

Insufficient surface preparation to substrate, levels not in accordance with design/specification, noncompatible materials, materials not used in accordance with manufactures requirements.

Start with an approved design/specification managed through a robust Inspection Test Plan (ITP) and Work Inspection Record (WIR) system.

Key checkpoints include;

- Check design for end user floor loading requirements.
 - Ensure material approvals are in accordance with specification.
 - Ensure an accepted ITP and Work Inspection Record (WIR) are in place before works commence.
 - Design in movement joints and positions of day joints as required for some if not all systems
 - Check level datums and construction tolerances for correct cover particularly for thresholds, insulation, embedded services and the camber of precast elements.
 - Follow manufactures instructions
 - Prepare the work area including cleaning and priming surface.
 - Maintain a suitable working environment i.e. openings closed, no water ingress, specified temperature range
-
